**Water Leakage Evaluation
Palos Heights Public Library
12501 South 71st Avenue
Palos Heights, Illinois**

BTC Project No. 25-128
May 30, 2025

Building Technology Consultants, Inc.

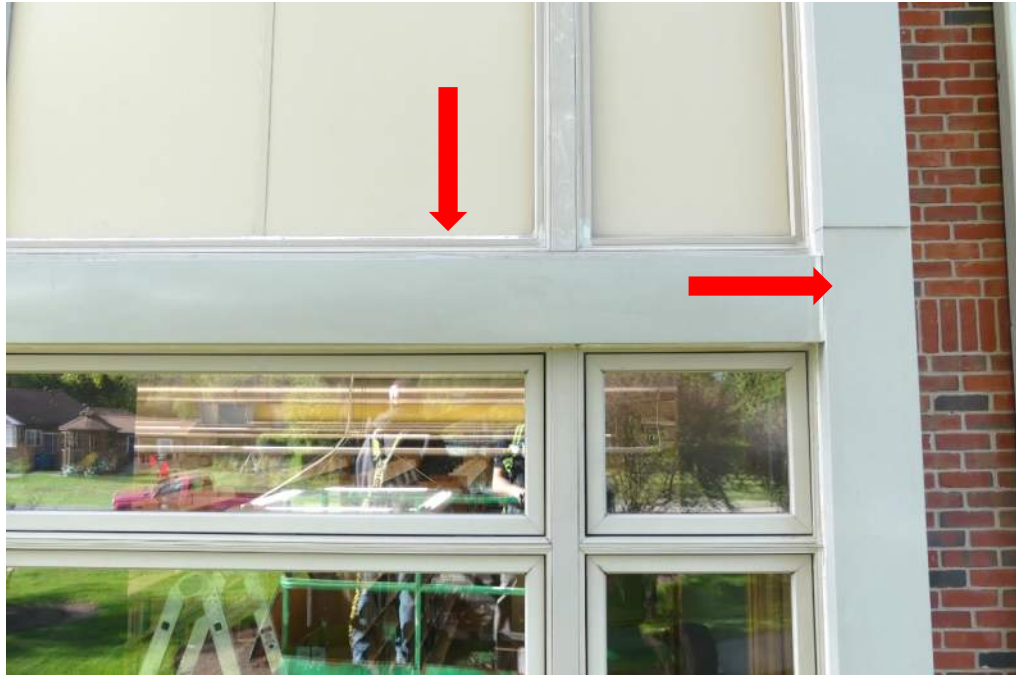
1. Varying colors of sealant were observed along joints between cladding panels, which suggests that repairs have been attempted more than once (Photo 1). The sealant was exhibiting adhesive and/or cohesive failure at several locations (Photos 2 and 3). No sealant was observed at some joints including between slab edge covers and column covers, and at column cover splices (Photo 4).

Photo 1 – Varying sealant colors

1. **Repair Option 1:** Remove all sealant from joints between metal panel cladding components and along window perimeters. Prepare surfaces and provide new liquid-applied sealant and/or pre-formed silicone strips.

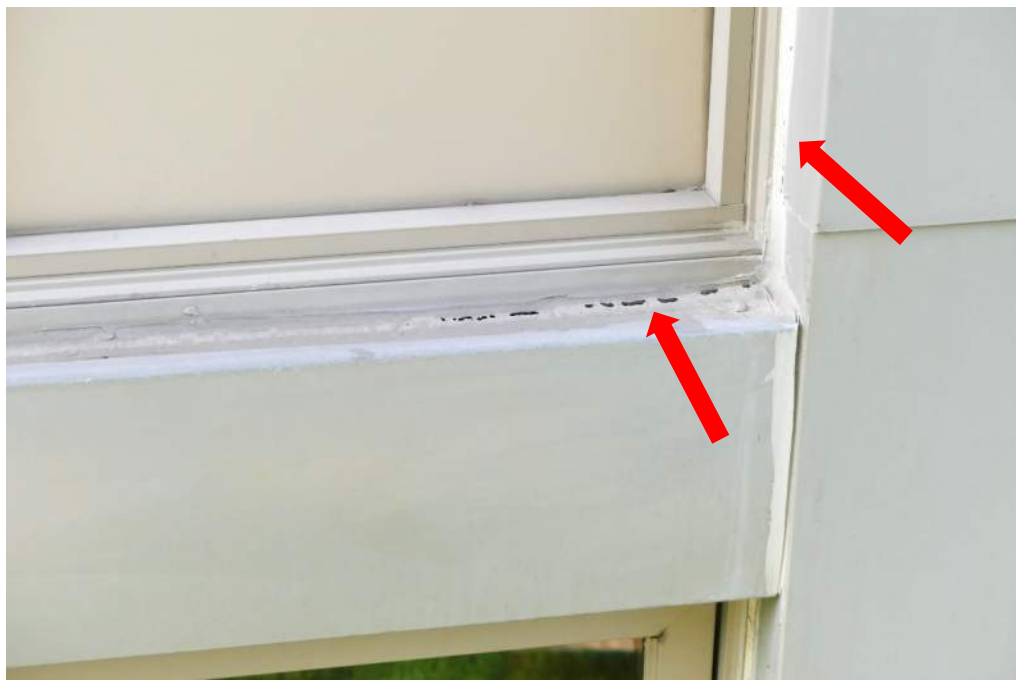
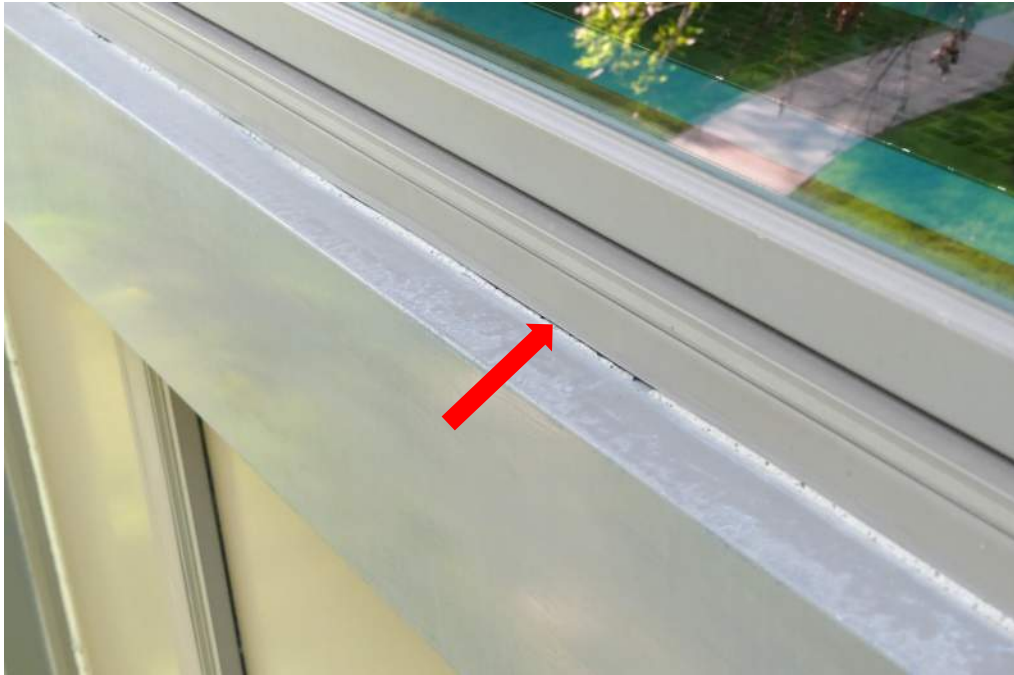
1. Failed sealant at joints between metal panel cladding components is allowing water to get behind the cladding system.
2. It does not appear that the metal panel clad walls were designed and/or constructed with an adequate internal drainage system. As such, water that gets past the metal panel cladding has direct pathways to reach the interior.

Photo 2 – Sealant exhibiting cohesive failure

Photo 3 – Sealant exhibiting cohesive and adhesive failure

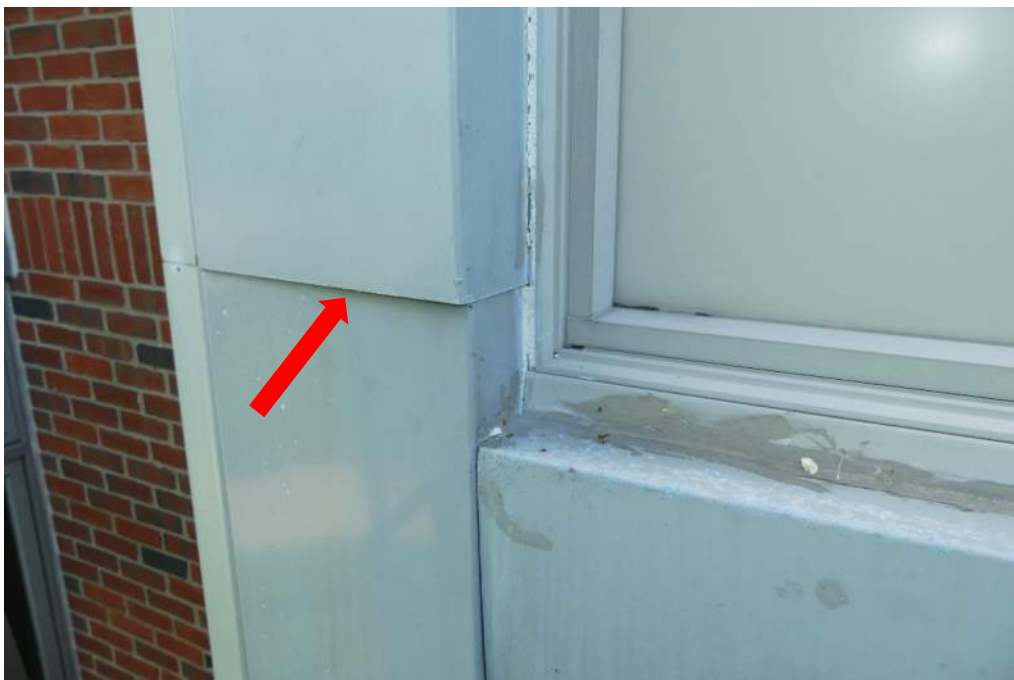
Photo 4 – No sealant at column cover splice

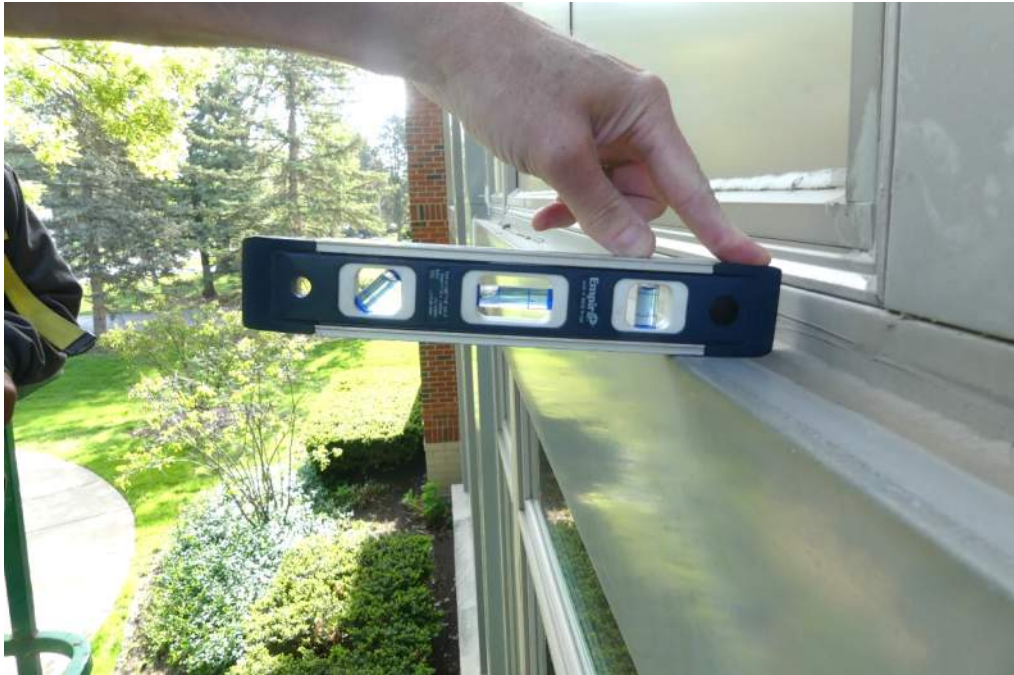
2. Most of the horizontal sill covers were observed to be back-pitched (Photo 5). The sill cover above the first floor window at the west bay window was loose and one end could be pulled away from the wall by hand (Photo 6).
3. Evidence of prior leaks was observed on the interior at the middle and west bays on the 1st floor (Photos 7 through 10). We did not observe evidence of leaks at the bay windows on the 2nd floor.
4. We removed a ceiling tile at the middle bay to review conditions within the interstitial space above the ceiling (Photo 11). Evidence of prior leaks was observed on the wood framing for the spandrel panels (Photo 12).
5. The as-built drawings indicated 3 inches of batt insulation and an air barrier behind spandrel panels. Neither insulation nor an air barrier were observed behind the spandrel panels (Photos 13 and 14).

Photo 5 – Back-pitched sill cover

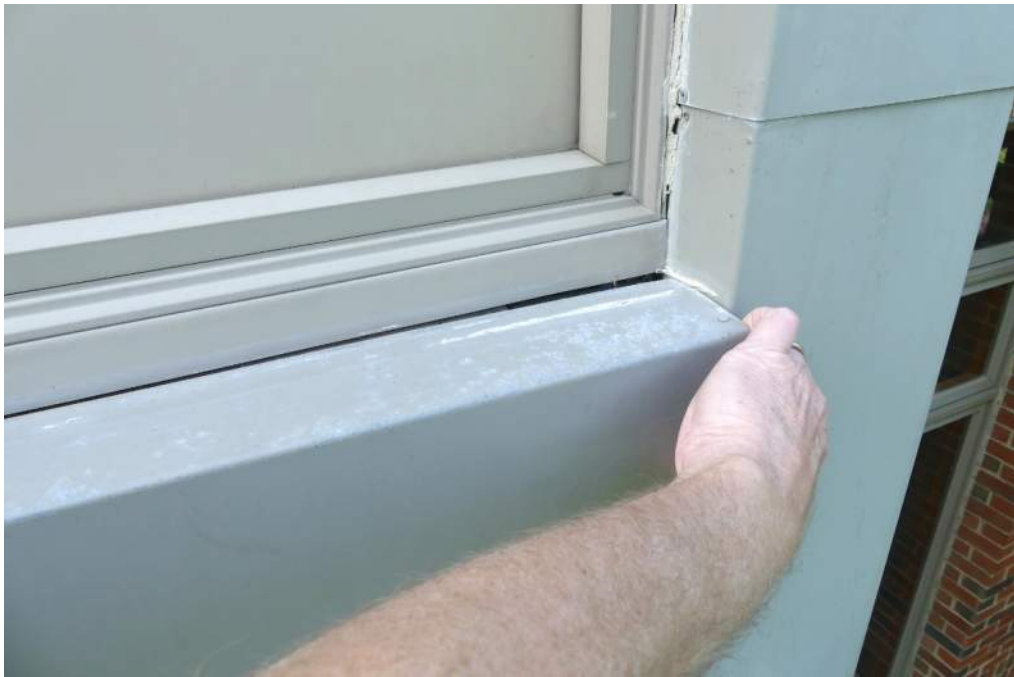
Photo 6 – Loose sill cover

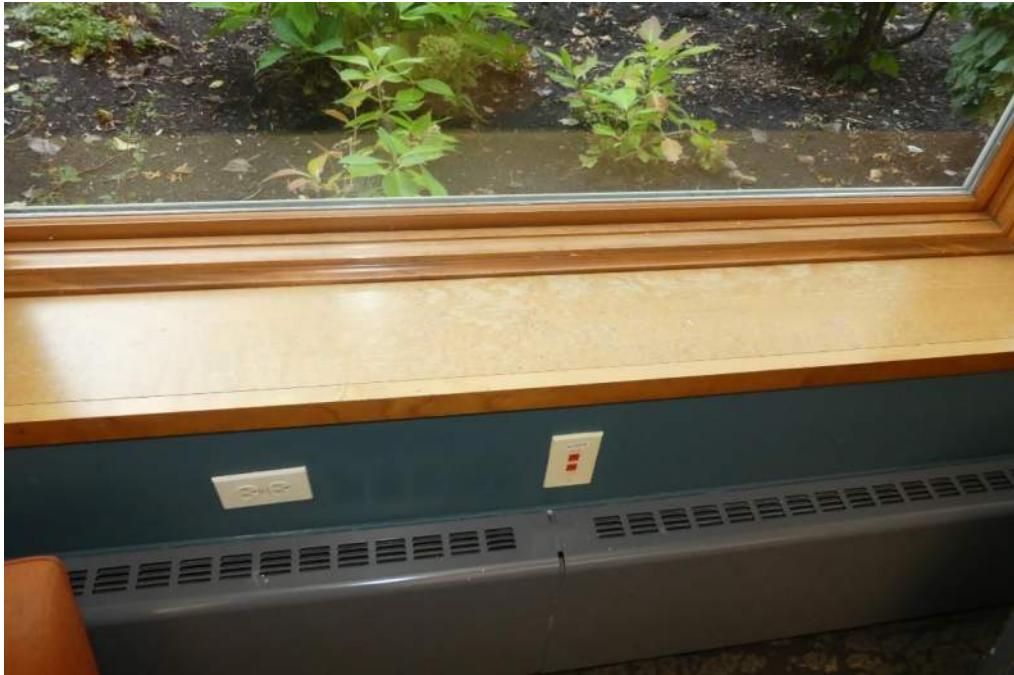
Photo 7 – Evidence of prior water leakage

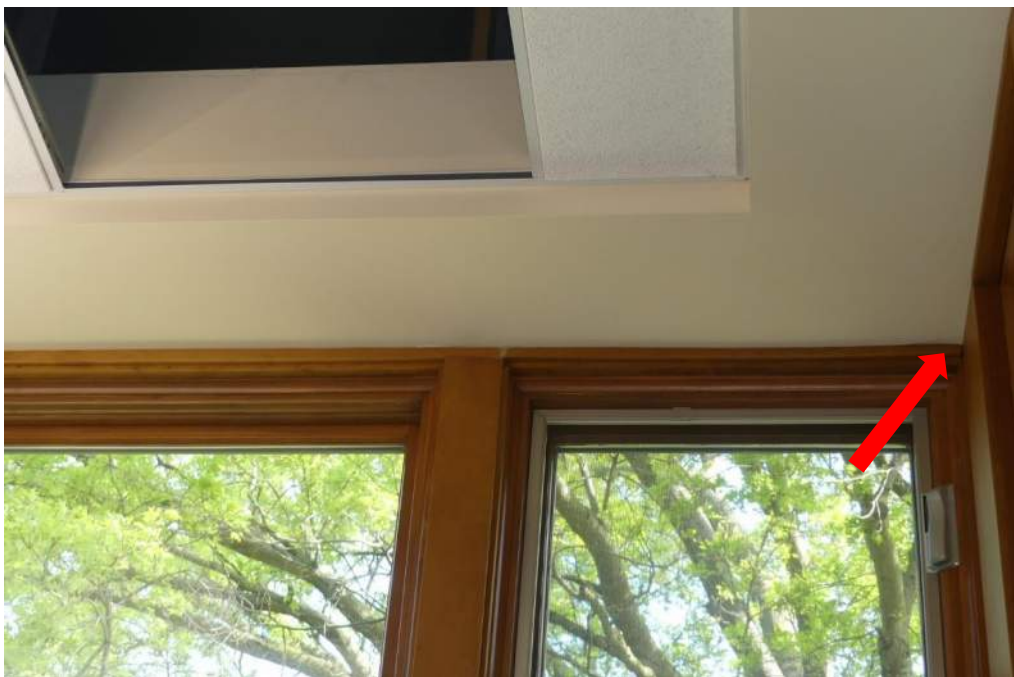
Photo 8 – Evidence of prior water leakage

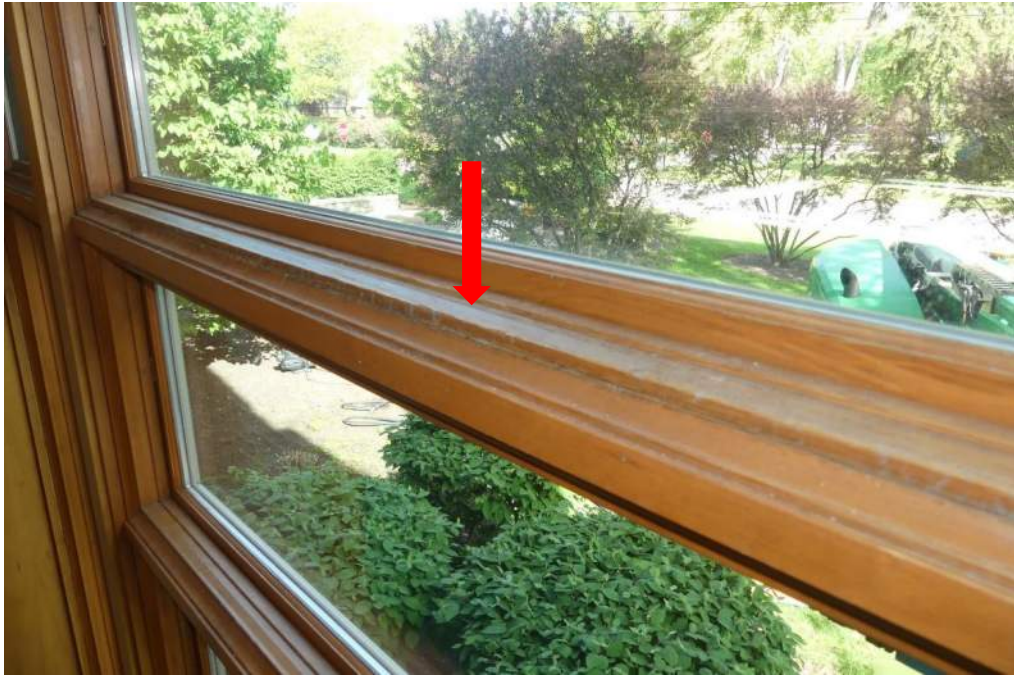
Photo 9 – Evidence of prior water leakage

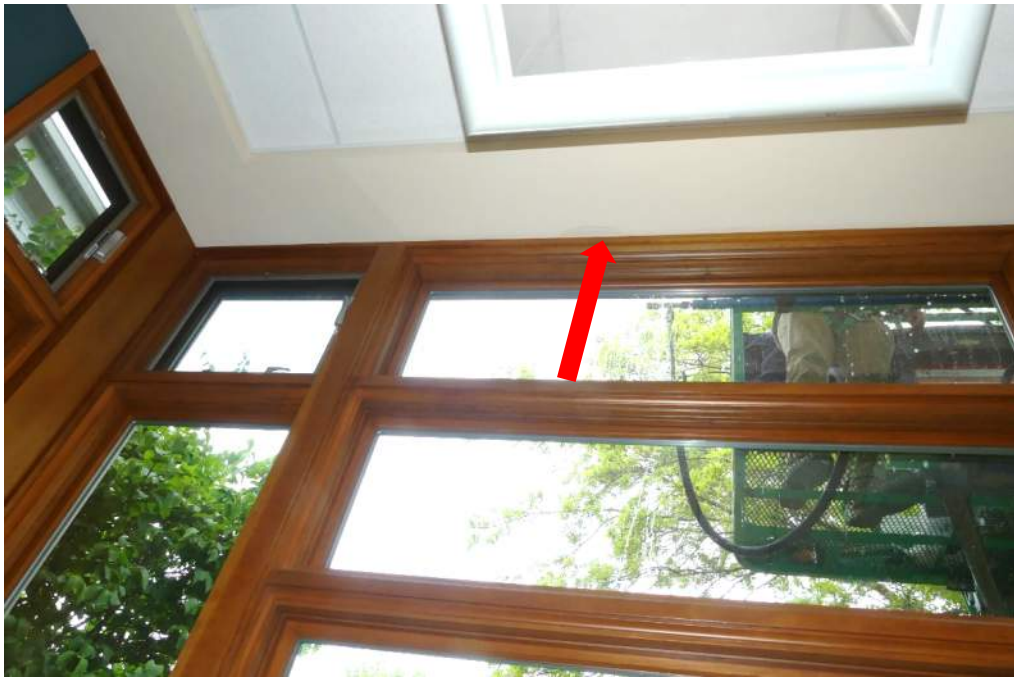
Photo 10 – Evidence of prior water leakage

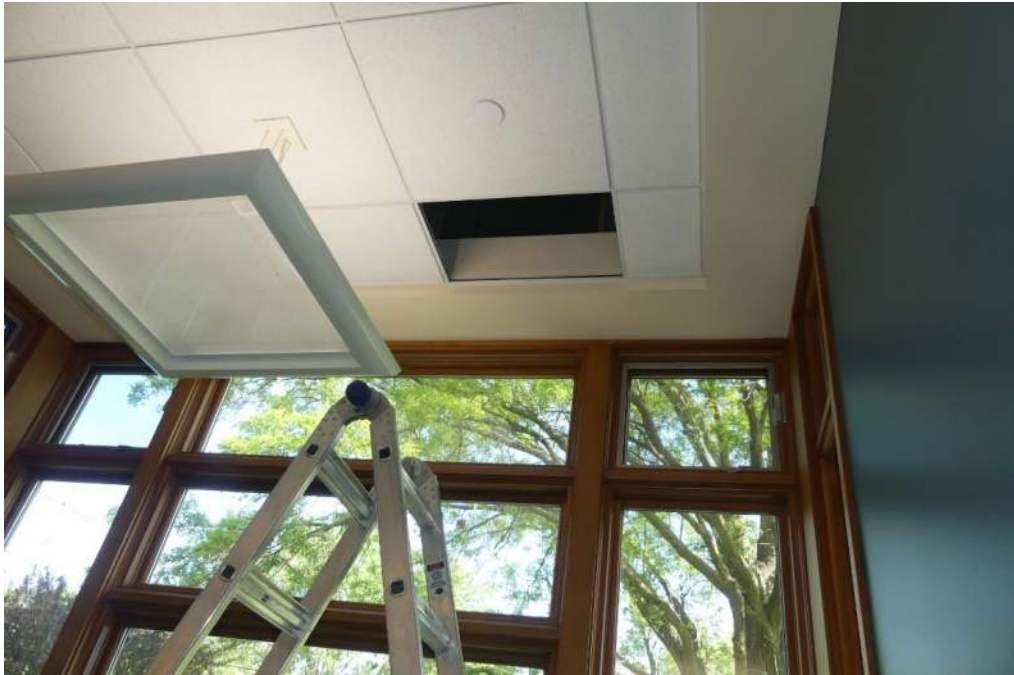
Photo 11 – Ceiling tile removed at middle bay

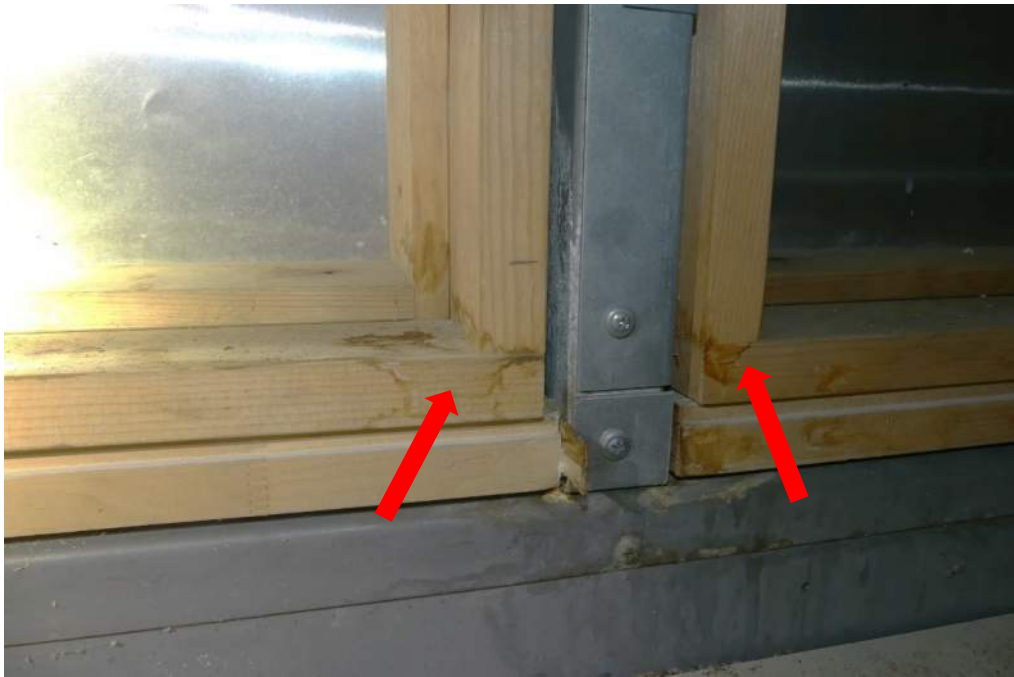
Photo 12 – Evidence of prior leaks on wood framing

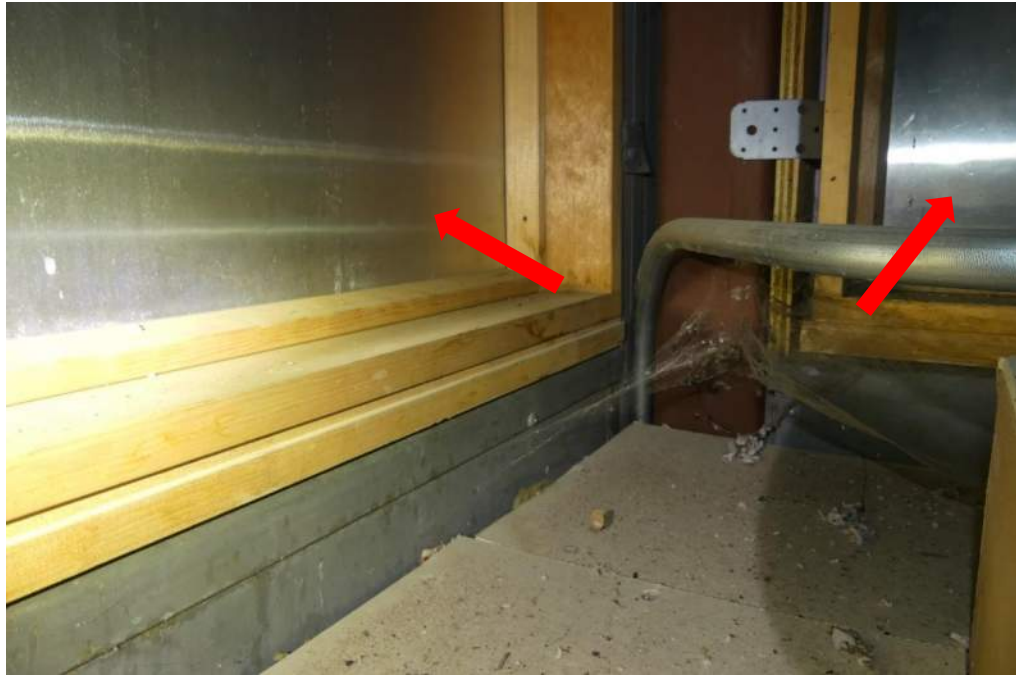
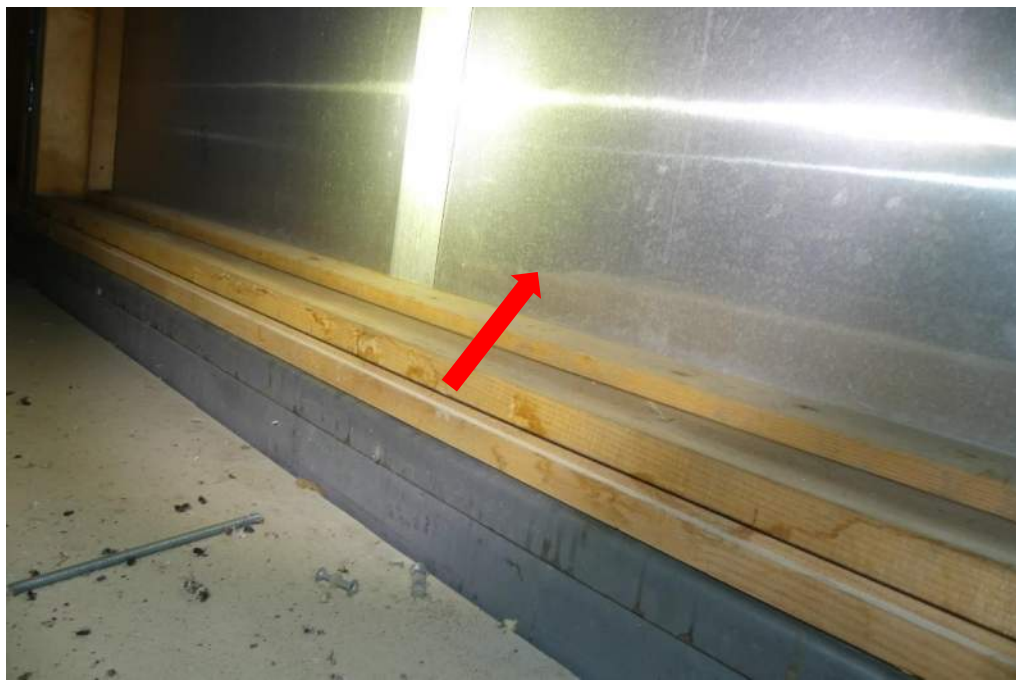
The lack of insulation behind the spandrel panels does not appear to be a deficiency that contributes to leaks. However, adding insulation behind the spandrel panels could improve energy efficiency throughout the building. This can be done in conjunction with the Repair Options 2 or 3 above, or as a separate project after the repairs are complete.

Photo 13 – No insulation or air barrier behind spandrel panels

Photo 14 – No insulation or air barrier behind spandrel panels

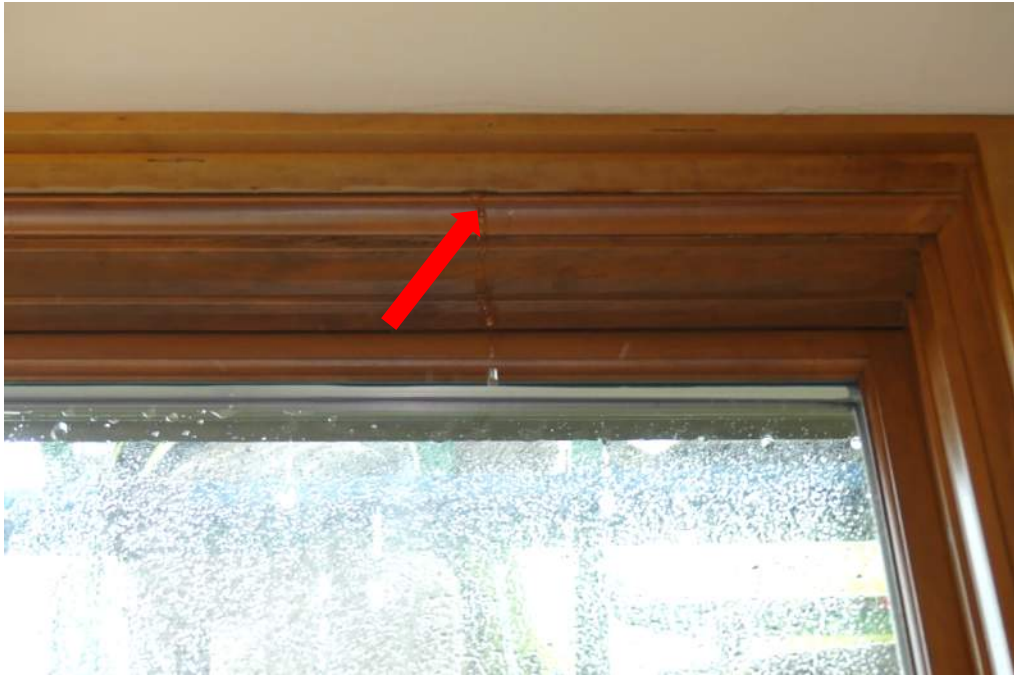
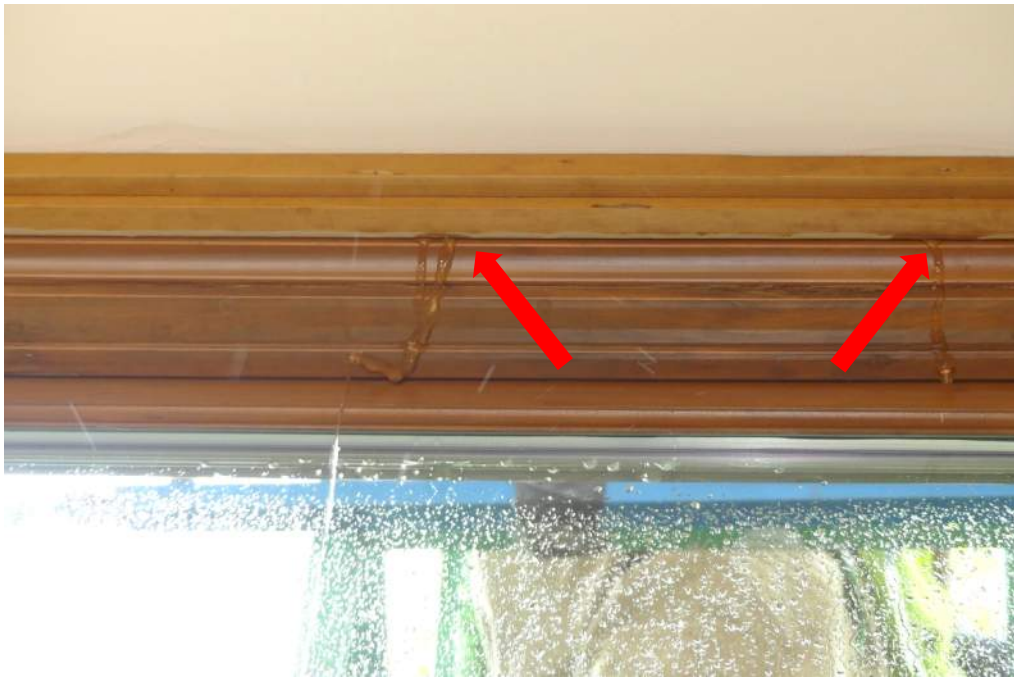
1. Leaks occurred during several tests along the sill cover and spandrel panels at the middle bay. The window assemblies did not appear to contribute to the leaks. The sill cover test was repeated at the west bay window. Leaks were observed within 5 minutes of the start of the test (Photos 19 and 20).
2. Water was observed dripping from along the joint between the window frame and the interior trim (Photos 21 and 22).
3. The most severe leaks occurred when the sill of the 2nd floor window was tested (Photo 23). Water collected on and around the spandrel panel frames during this test (Photos 24 and 25).

Photo 19 – Leak emanating between frame and trim

Photo 20 – Leak emanating between frame and trim

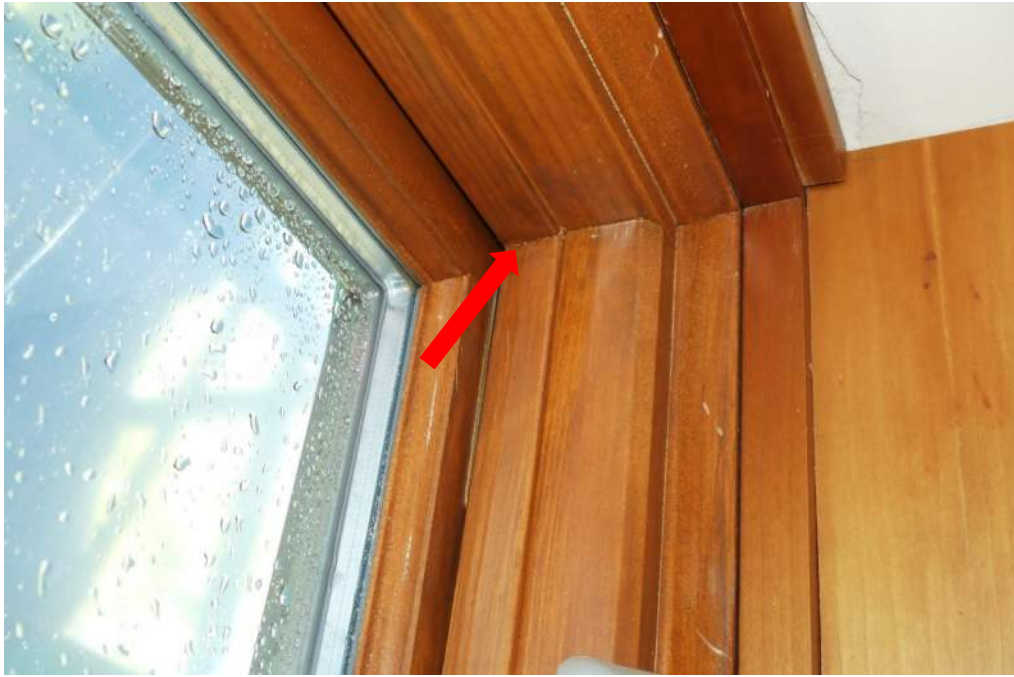
Photo 21 – Leak emanating between frame and trim

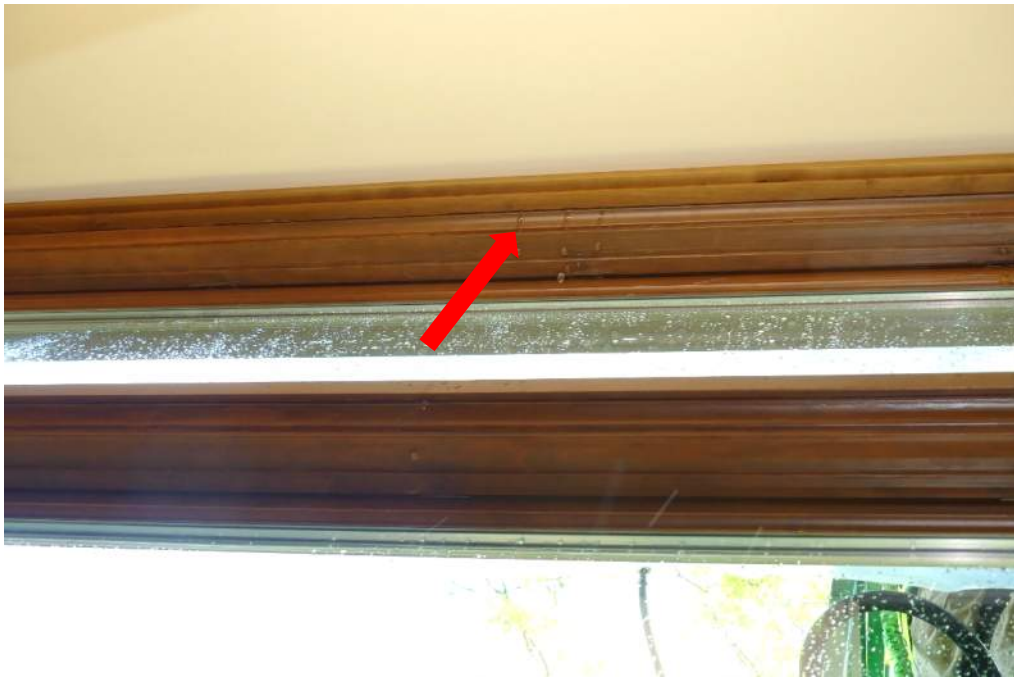
Photo 22 – Leak emanating between frame and trim

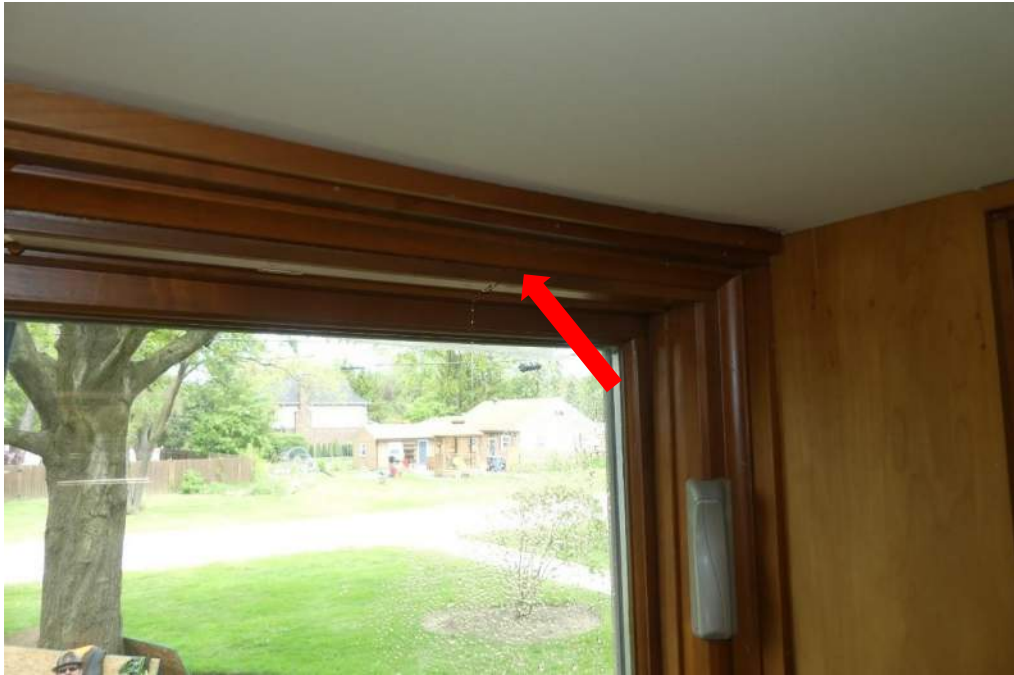
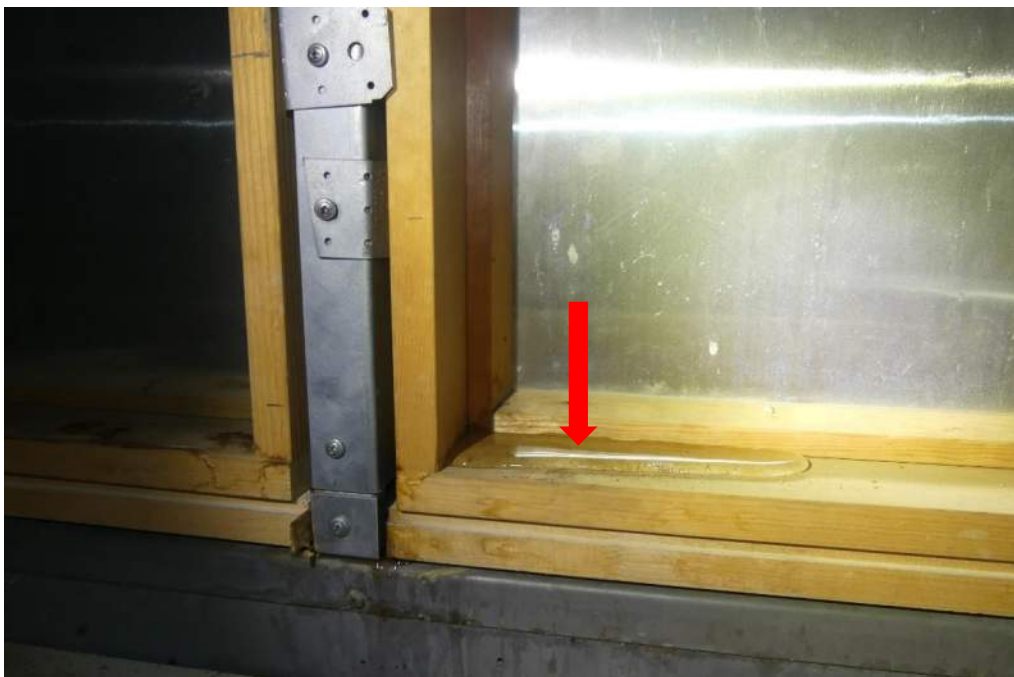
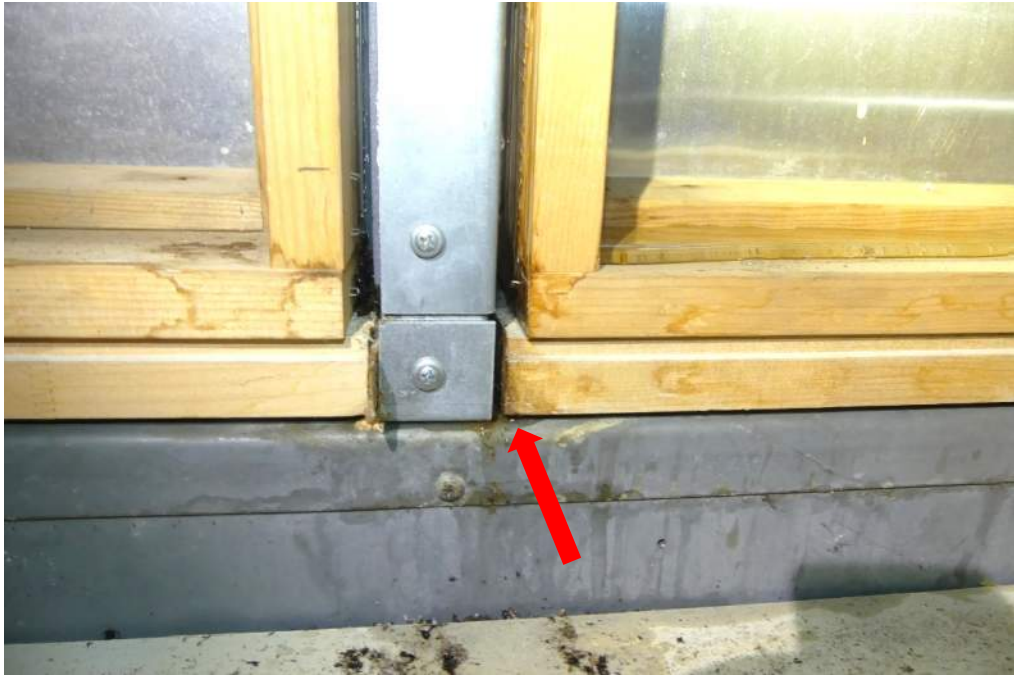
Photo 23 – Leak observed during test along 2nd floor window sill

Photo 24 – Leak observed during test along 2nd floor window sill

Photo 25 – Leak observed during test along 2nd floor window sill

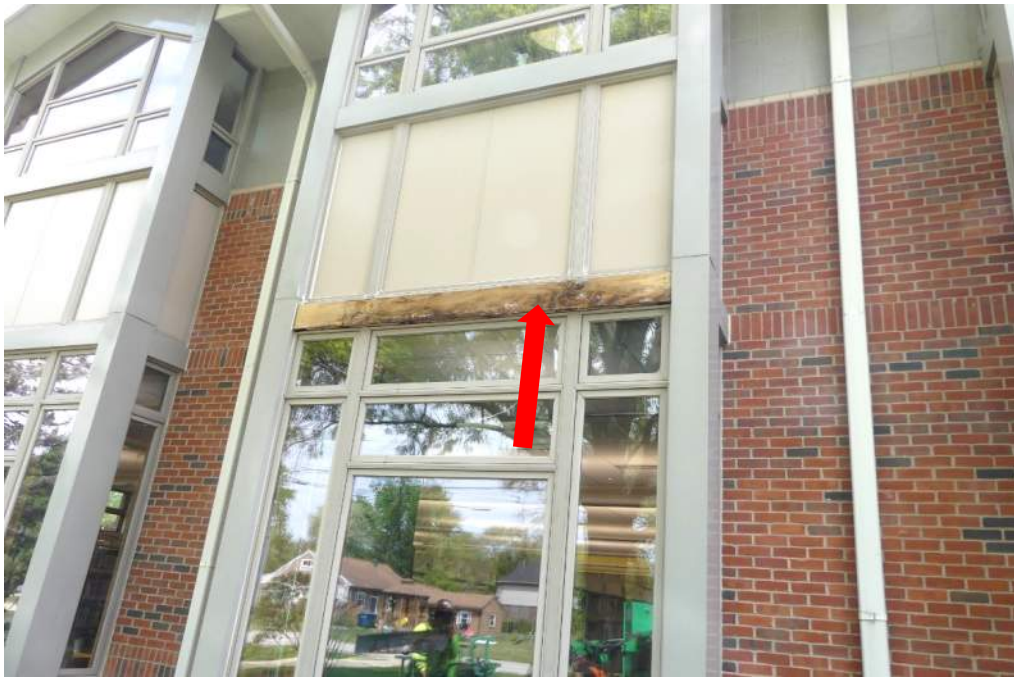
2. The plywood sheathing behind the metal panels exhibited evidence of prolonged exposure to moisture (Photo 26).
3. The rigid insulation was held in place with screws creating a penetration through the flashing membrane (Photo 27).

Photo 26 – Plywood sheathing exhibiting evidence of prolonged exposure to moisture

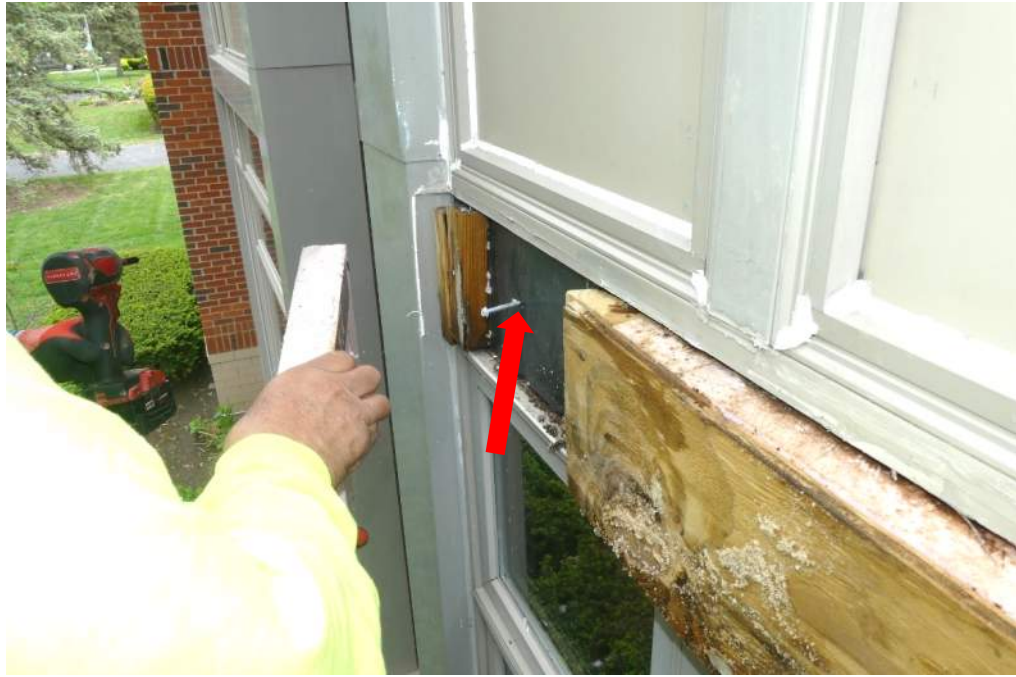
Photo 27 – Screw through insulation

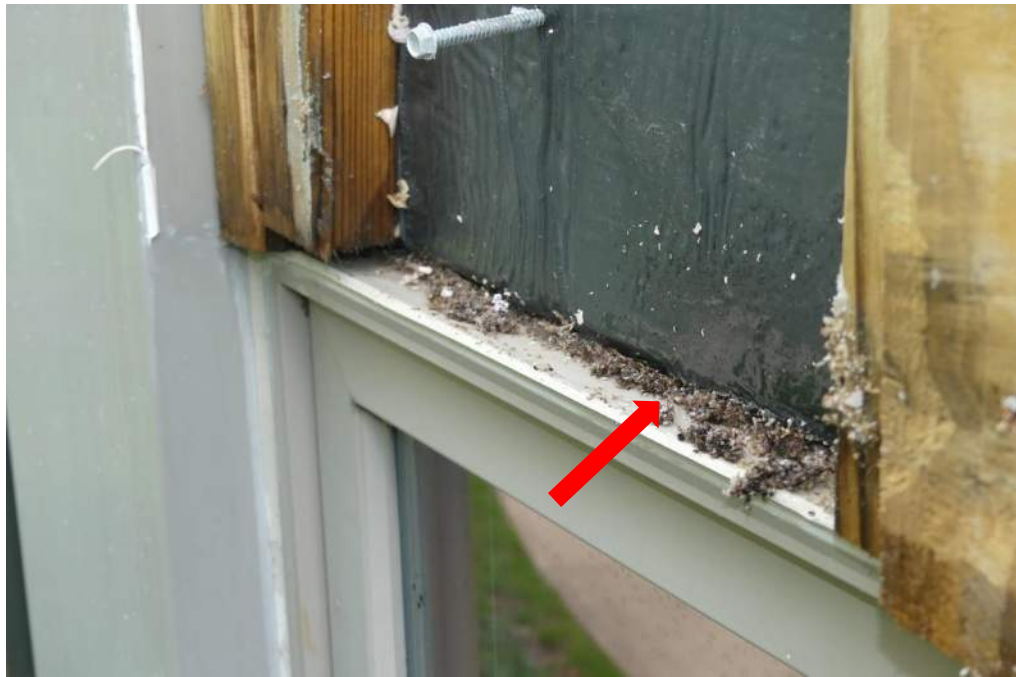
4. Significant debris was observed collecting along the top of the window (Photo 28). The flashing membrane loosely wrapped back toward the interior at these locations and moisture was identified within the gap between the membrane and top of the window frame (Photo 29).

Photo 28 – Debris along top of window

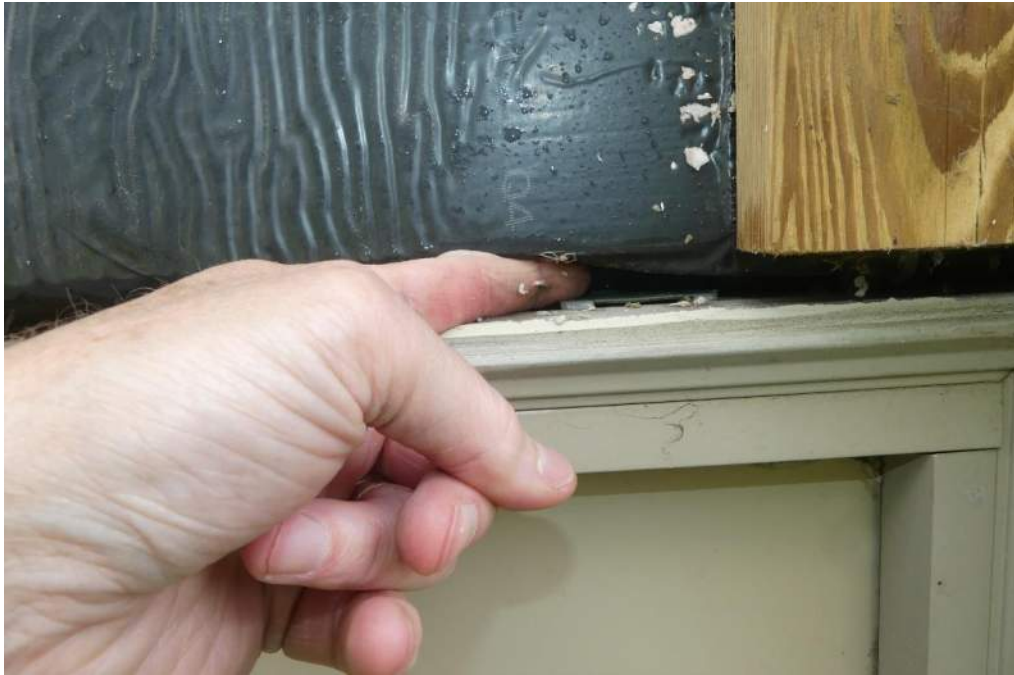
Photo 29 – Moisture in gap between flashing membrane and spandrel panel

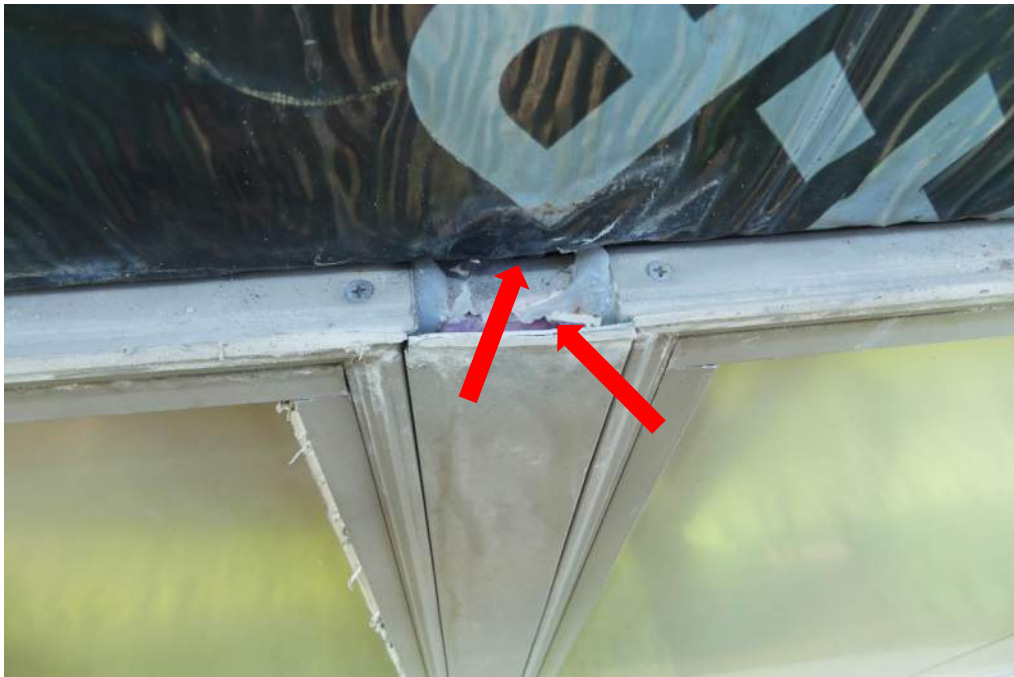
5. Vertical mullion caps separate the spandrel panels. The top of the spandrel panel mullion cap was observed to be open where the sill cover was removed below the 2nd floor window (Photo 30).

Photo 30 – Openings in top of mullion cap

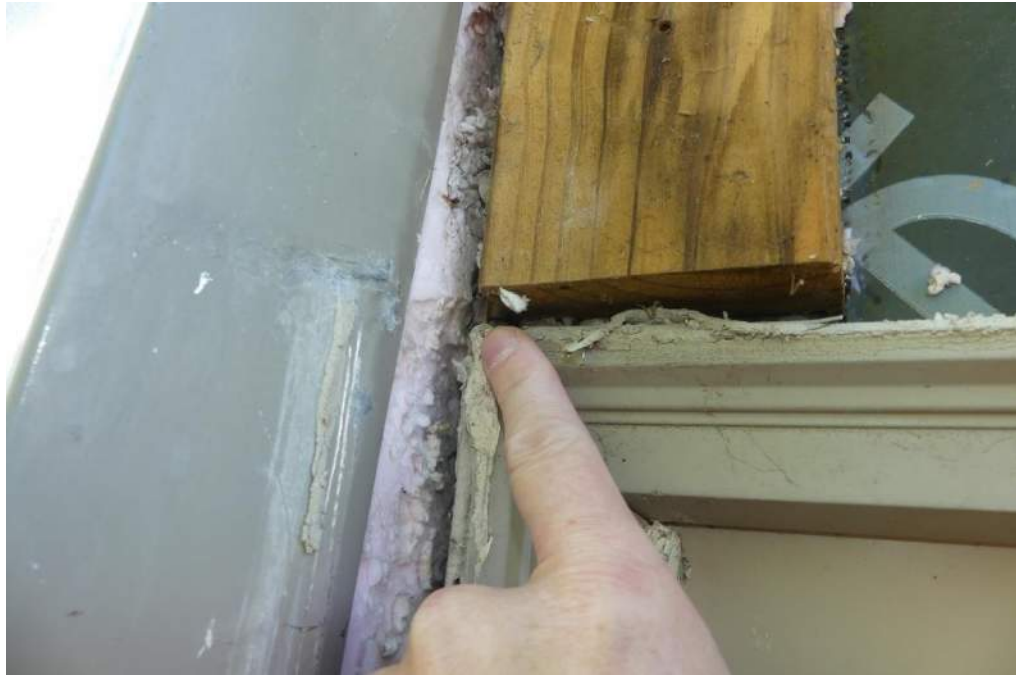
6. The column covers could not be removed without disassembling more of the cladding system. A column cover was partially pulled open to review the underlying conditions (Photos 31 and 32). The vertical joint between the spandrel panels and the vertical framing at the corner was open (Photo 33). There appeared to be a flashing membrane behind the insulation (Photo 34). However, we were not able to confirm if the membrane was continuous.

Photo 33 – Open joint between spandrel panel and vertical framing
